Bridges Survey in the South-West of UK

By Reinaldo Alvarez Cabrera

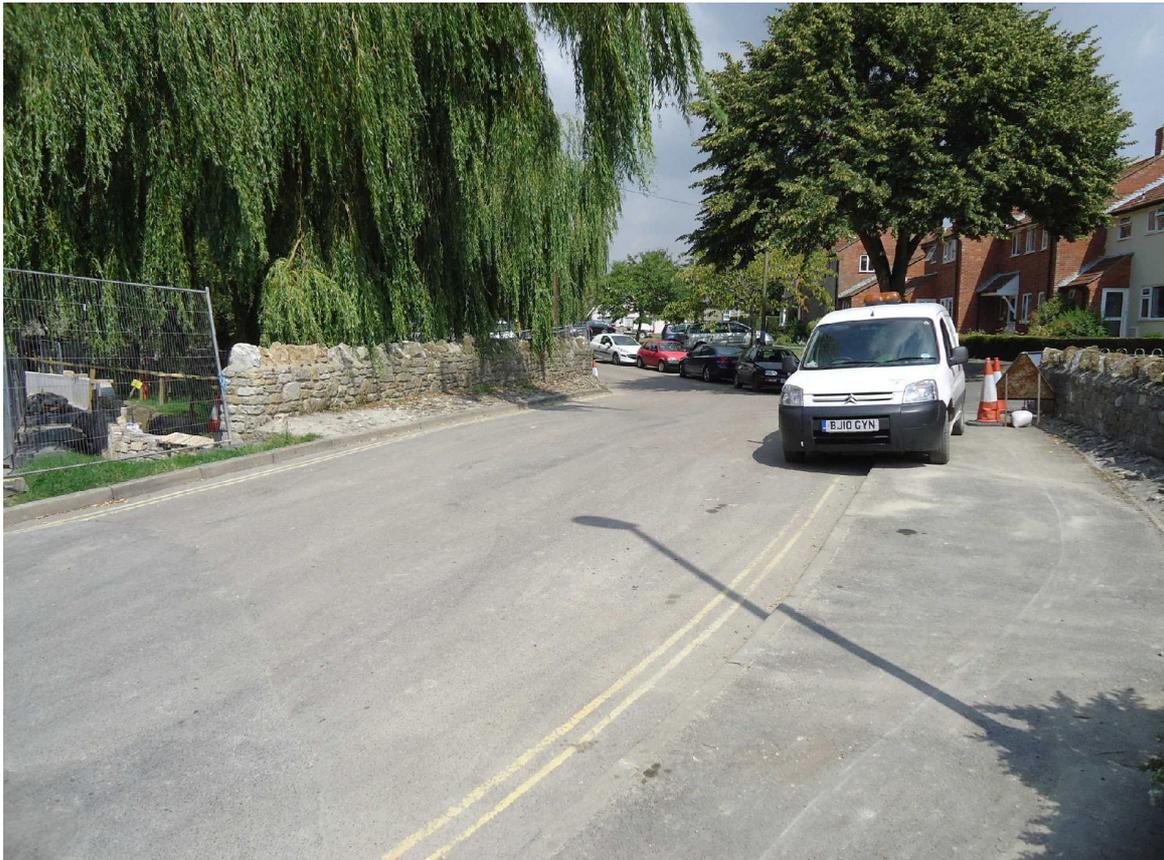
Fig. 3 The first bridge to survey.

In the first survey we were supposed to find out whether or not a bridge over a small creek had reinforcing bars in it or not. We were also required to find out the extend of these re-bar mesh, if it existed, and any weak point there might be in it. We went from the place where we had left the car doing a survey of the road to the bridge, over it and a little bit further. The re-bar mesh on the bridge was easily identified on the resulting profile, but it was bent down, sort of like hanging down. This, of course couldn't be right, and to my great personal surprise the engineer from Interserve Plc accompanying us pointed out the correct reason for that! The bridge had a slight mound over it so the actual depth to the

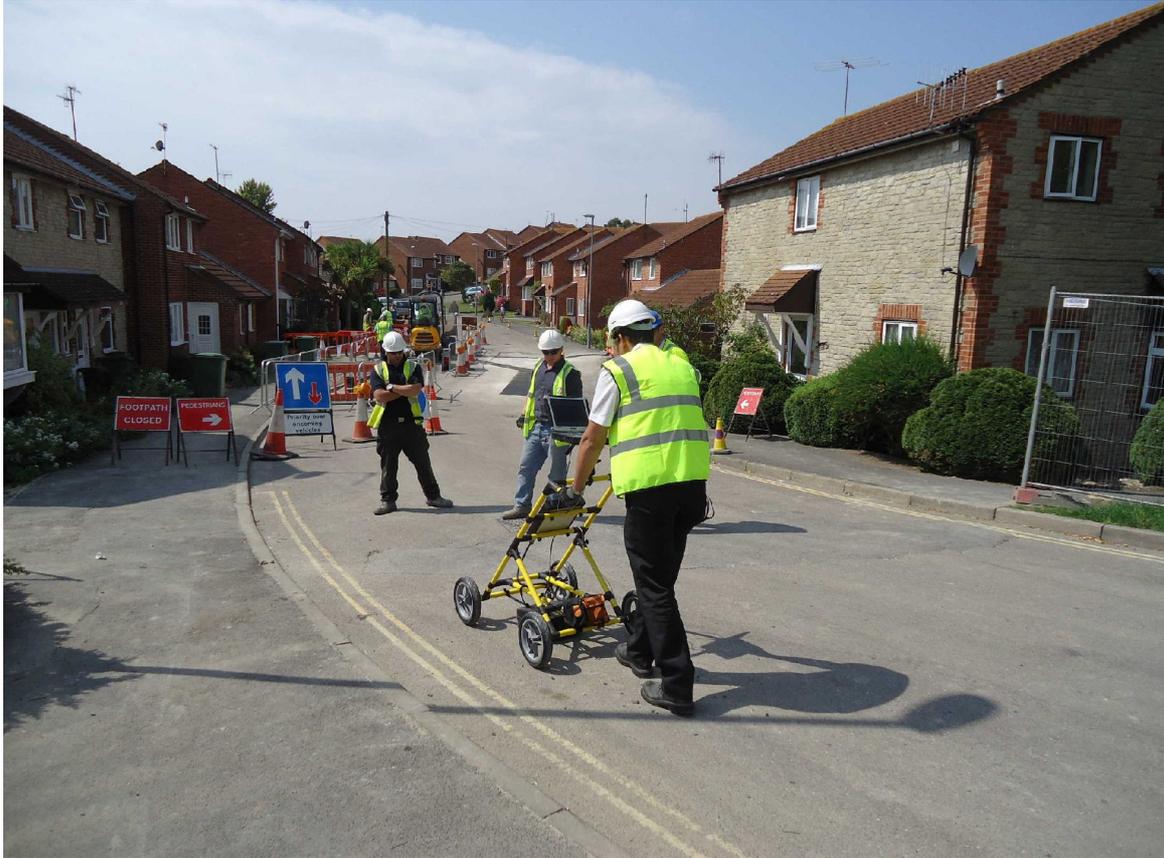
re-bar mesh was constantly changing while walking with the survey cart over it. (Fig. 4 and 5)

Fig. 5 Going downhill from the bridge.

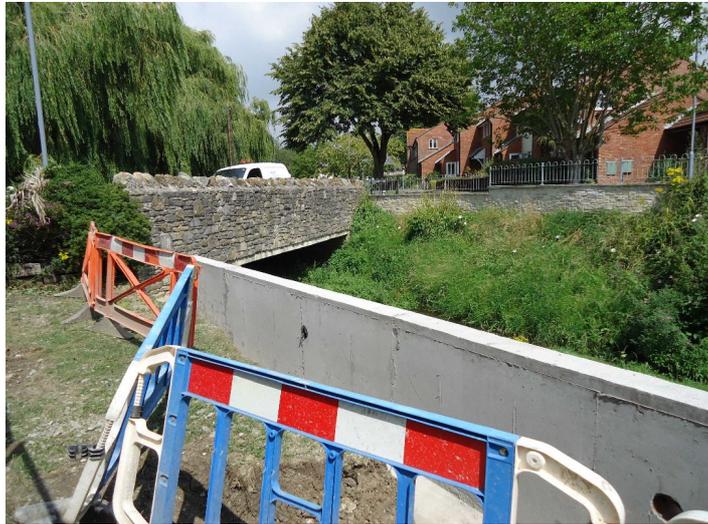
None the less, the objective of the survey had been accomplished and we could identify that indeed there was a re-bar mesh there and that it had a couple of weak points, probably due to corrosion of the metal in the mesh or just moisture from the underlying creek. (Fig. 6)

Fig. 6 The first bridge under survey.
